Inspection Report

Mine Name: ECDC Clay Mine
Operator Name: ECDC Environmental

Permit number: M0150062
Inspection Date: April 12, 2007
Time: 1:25-1:55 PM

M/015/062, ECDC Clay Mine, ECDC Environmental

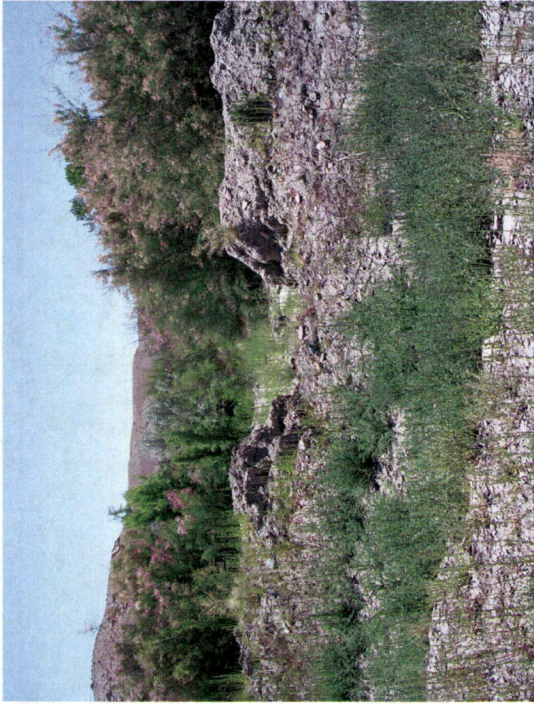
The mine is bordered on the south by the Price River, and except for an area next to a spoil pile, there are berms between the mine and the river. The mine has a pad where clay had been stockpiled, and this pad, together with some of the rest of the mine, is sloped so water flows toward the berm (see Photo 1). This berm was breached—probably during a heavy rainstorm last fall—allowing water from the pad to flow into the river (Photos 1 and 2).

Photo 1. A breach in the berm near the bottom of the hill by the entrance gate.

The operator should regrade the stockpile pad so it slopes away from the river as shown in the mine plan, and the berms along the river need to be repaired.

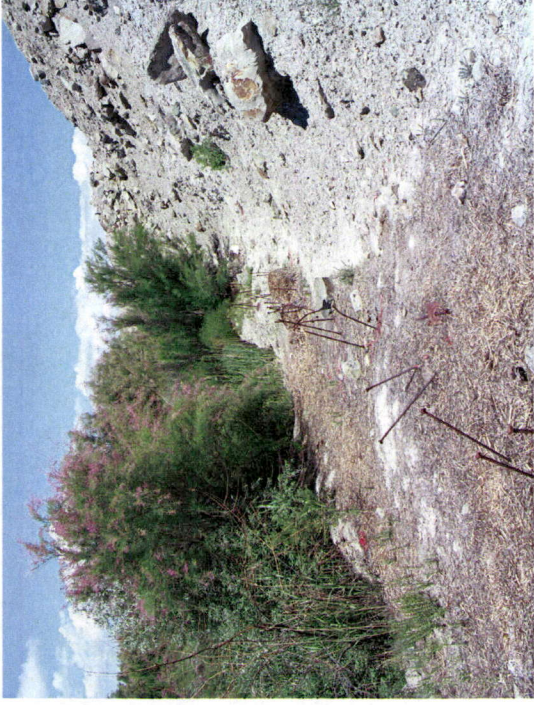
Shown in Photo 3 and in the foreground of Photo 1 is another berm, and there was a hole where water had piped through this berm (Photo 4).

Photo 3. The remains of straw bales along the overburden/spoil pile.

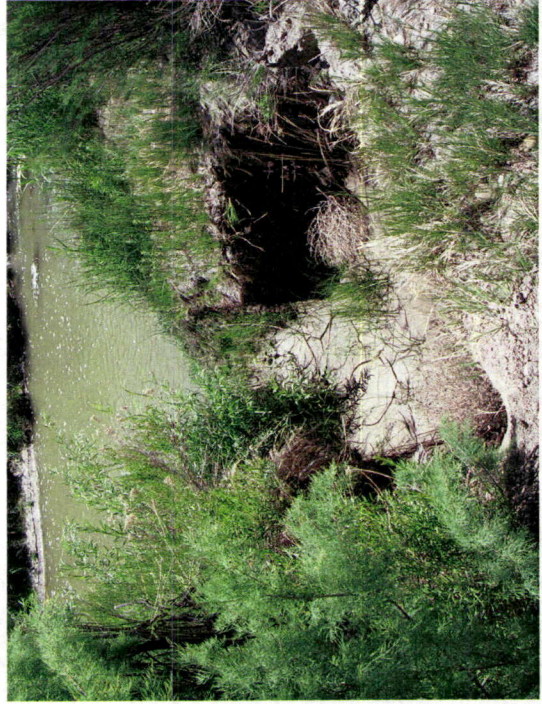
Photo 2. This is where water flows into the Price River after going through the breach shown in Photo 1.

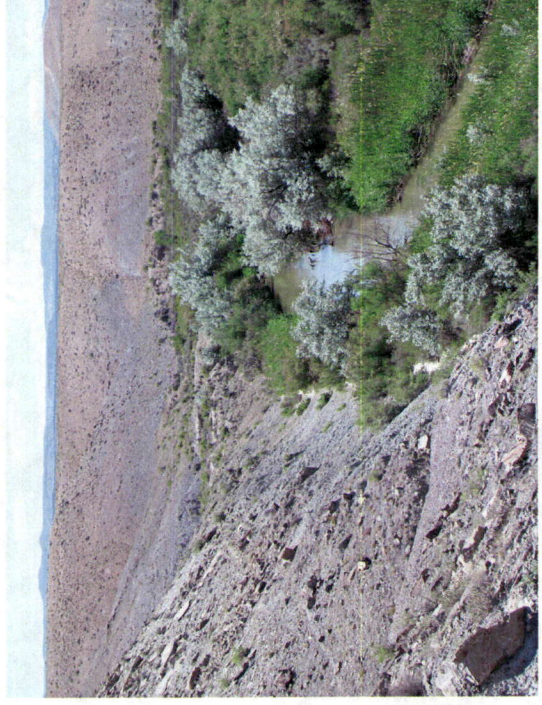
Photo 4. A nearby undisturbed area with a nearly-barren slope ending at the riparian area next to the river.

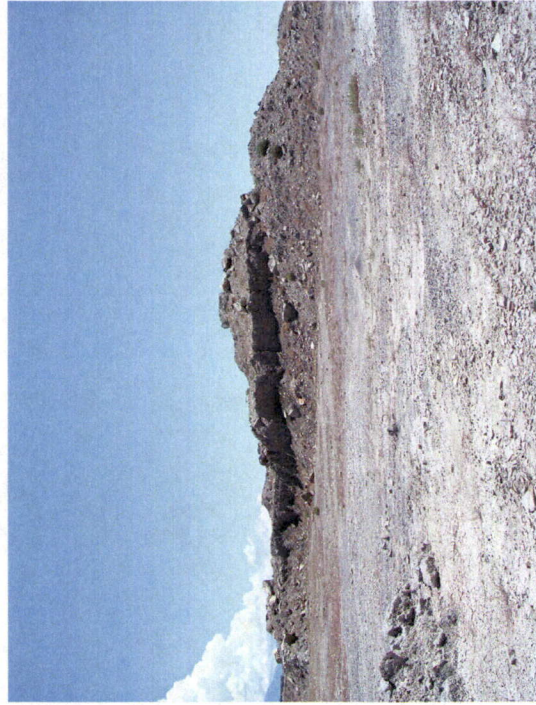
Photo 5. The topsoil stockpile.

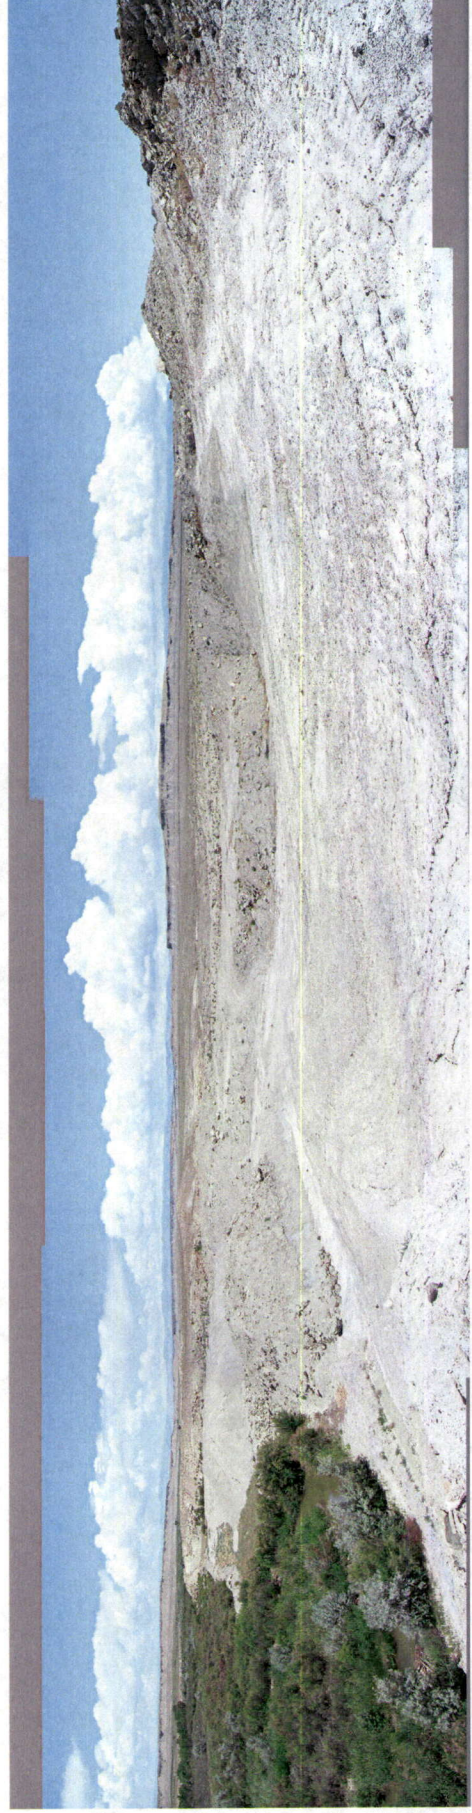
Photo 6. A panorama taken from the southeast part of the site. The straw bales in Photo 3 are in the left center of this photo.
